capacitive sensor
BC5-S18-AP4X

capacitive sensor

BC5-S18-AP4X

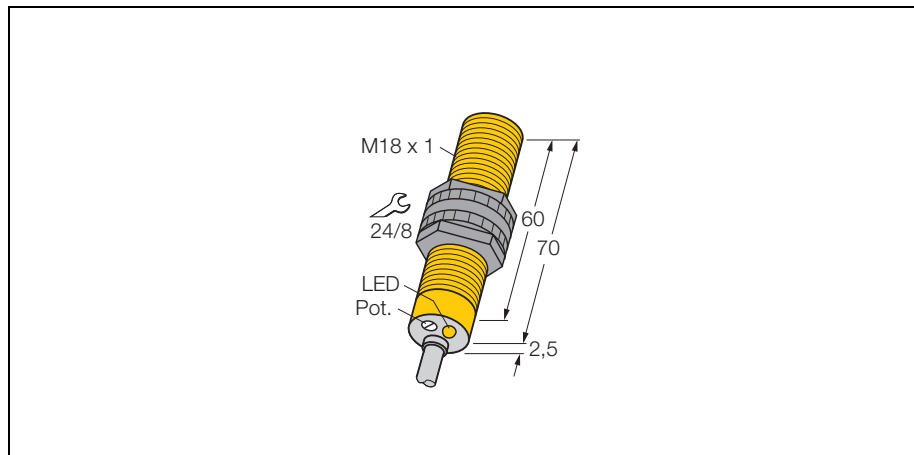
- threaded barrel, M18 x 1
- plastic, PA12-GF30
- fine adjustment via potentiometer
- 3-wire DC, 10..0.65 VDC
- normally open, pnp output
- cable connection

Type	BC5-S18-AP4X
Ident-No.	25030
Rated operating distance Sn	5 mm, flush mounting
Rated operating distance Sn	7.5 mm, non-flush mounting
Hysteresis	2... 20 %
Temperature drift	≤ ± 20 %
Repetition accuracy	≤ 2 %
Ambient temperature	-25...+ 70 °C
Operating voltage	10... 65 V DC
Residual ripple	≤ 10 % U _{SS}
DC rated operational current	≤ 200 mA
No-load current I ₀	≤ 15 mA
Residual current	≤ 0.1 mA
Switching frequency	≤ 0.1 kHz
Rated insulation voltage	≤ 0.5 kV
Output function	3-wire, normally open, pnp
Short-circuit protection	yes / cyclic
Voltage dip at I _e	≤ 1.8 V
Wire breakage / reverse polarity protection	yes / complete
Housing style	threaded barrel; M18 x 1
Dimensions	70mm
Housing material	plastic, plastic, PA12-GF20
Material active area	plastic, PA12-GF30
Housing nut tightening torque	2 Nm
Connection	cable
cable quality	Ø 5.2, LiYY, PVC, 2 m
Cable cross section	3 x 0.34 mm ²
Vibration resistance	55 Hz (1 mm)
